Inspection Report
Minerals Regulatory Program
August 18, 2005

Mine Name: End of Trail/G&R 1-3

Permit number: S/025/010

Inspection Date: August 2, 2005

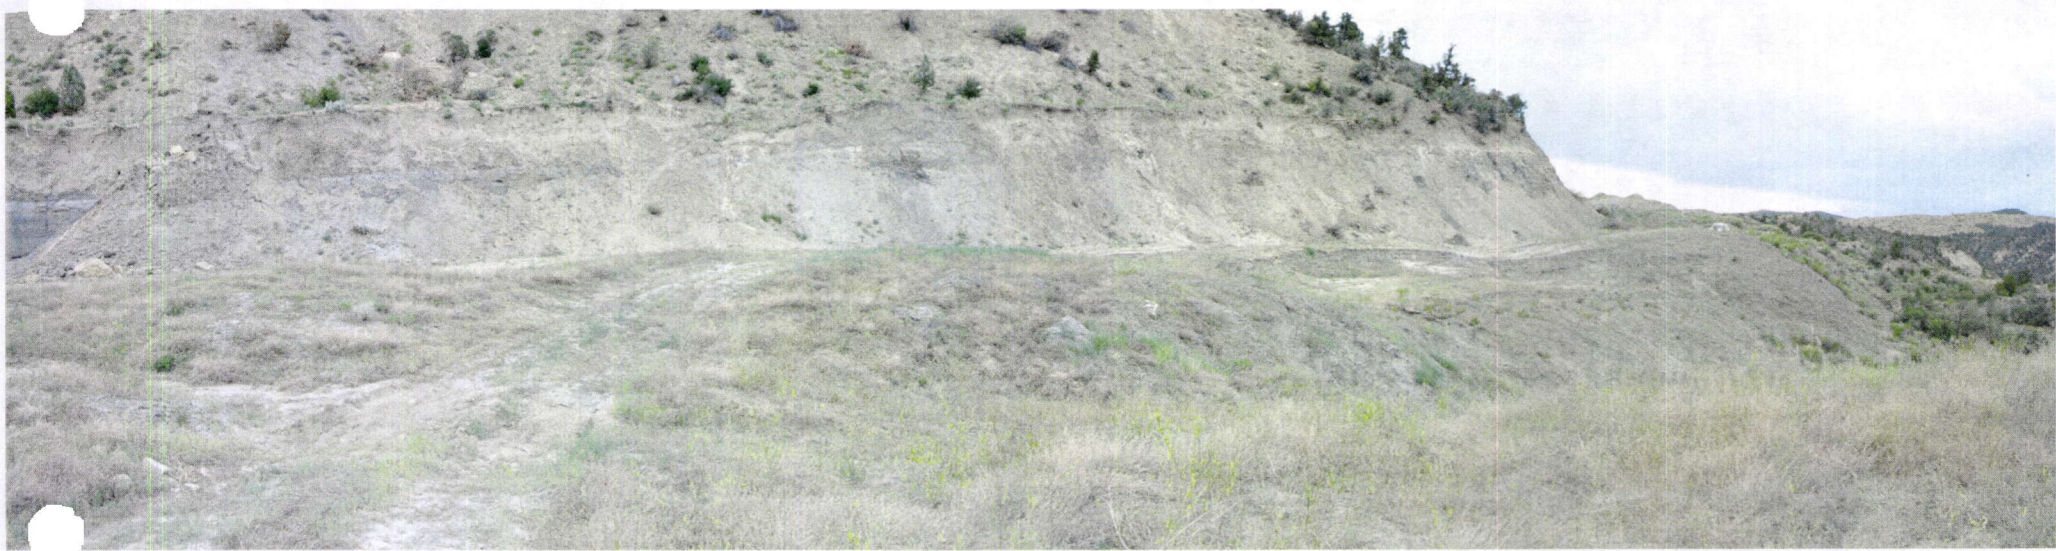
QUARRY LOOKING SOUTHEAST
WESTERN PORTION

The recontouring effort at the site looks good with the exception of an area near the center of the permit area where some slumpage of the recontoured material is taking place. The seeding success is very marginal, very little of the reseeding appears to grown.

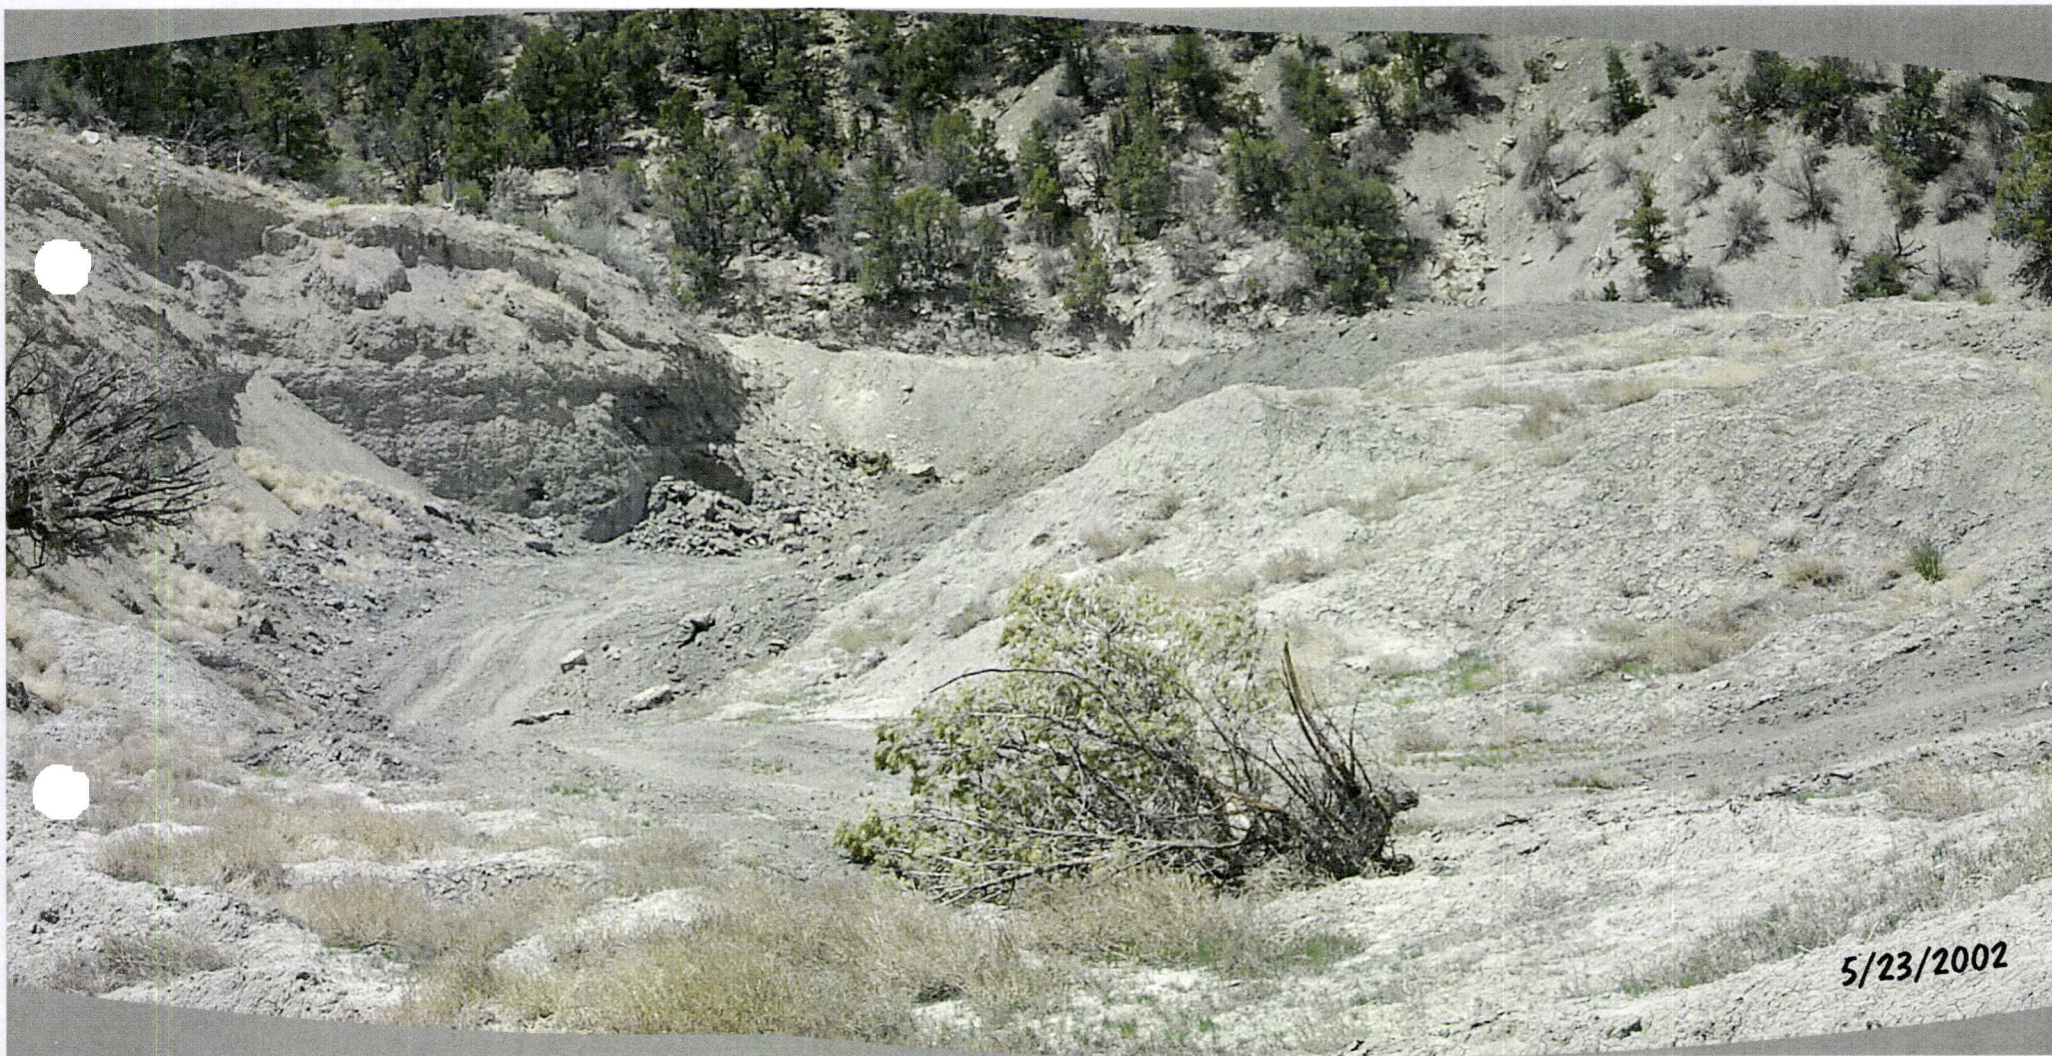
There appeared to be some recent disturbance in this area. A GPS map of this area was made. The mapping indicated that on this portion of the mine there was .83 acres of disturbance. There is an additional .23 acres of disturbance on the southern portion of this permit area where mining at the Tetla Septarian Nodules (S/025/006) has infringed into the End of the Trail permit area.

DISTURBANCE ON THE EASTERN PORTION OF THE MINE

I believe that on one of my next visits to the site, I will need to take a biologist with me to evaluate the vegetation on this site. I will contact the BLM to arrange for a dual site visit with the operator, to discuss any further reclamation work that may be required.
